# NATF Redacted Operating Experience Report

## 115 kV Motor Operated Air Break Switch Failure

115 kV Motor Operated Air Break Switch Failure

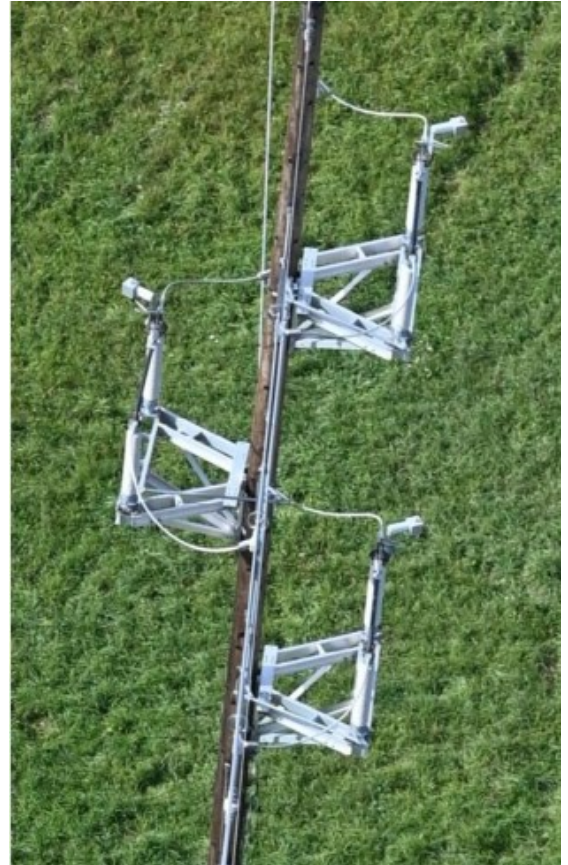
A transmission project crew was performing switching to isolate a 115 kV motor operated air break switch (MOAB) for maintenance. The switching involved having the crew manually open an adjacent 115 kV MOAB (figure 1) as a clearance point because the switch could not be operated remotely due to a weak radio signal.

A post-event laboratory analysis revealed that all three vacuum interrupters on the 115 kV MOAB had defective vacuum bottles. This was identified as the causal factor for the event.

1. The 115 kV MOAB was not properly aligned and adjusted, preventing the vacuum bottles from operating as designed.
2. The 115 kV MOAB had been motor operated an unknown number of times with visible arcing.
3. Opening the MOAB manually extended the arc duration.

Figure 1. Photo of affected MOAB switch

1. Included a vendor representative in the event investigation.
2. Updated the 8-year testing/maintenance cycle to include vacuum bottle testing and switch alignment.
3. Inspected other locations with single vacuum bottles on manual switches and scheduled necessary repairs.
