NATF Redacted Operating Experience Report

Improper Guy Anchor Installations

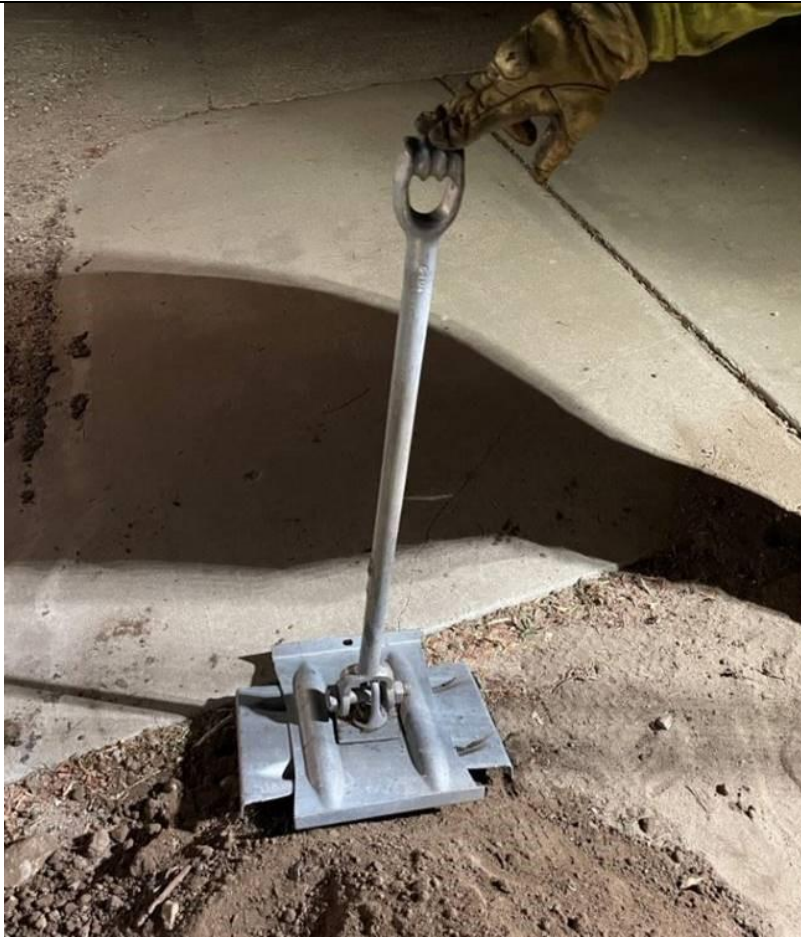
2' extension rod connected directly to a plate anchor utilizing an I-bolt

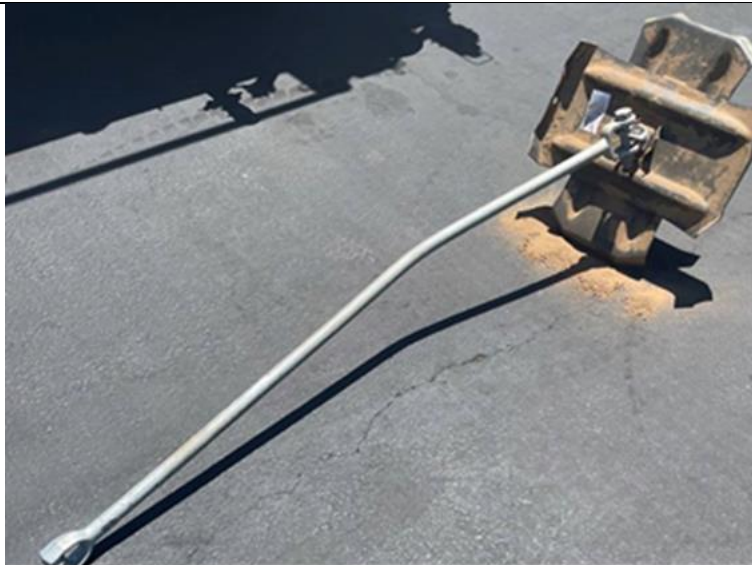
3' extension rod connected directly to a plate anchor utilizing an I-bolt

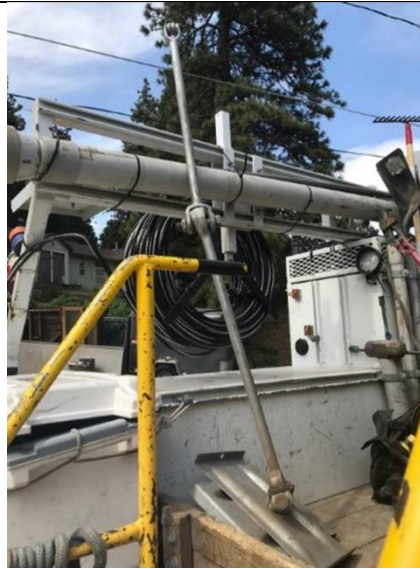
Two 3' extensions daisy chained and connected directly to a plate anchor utilizing an I-bolt

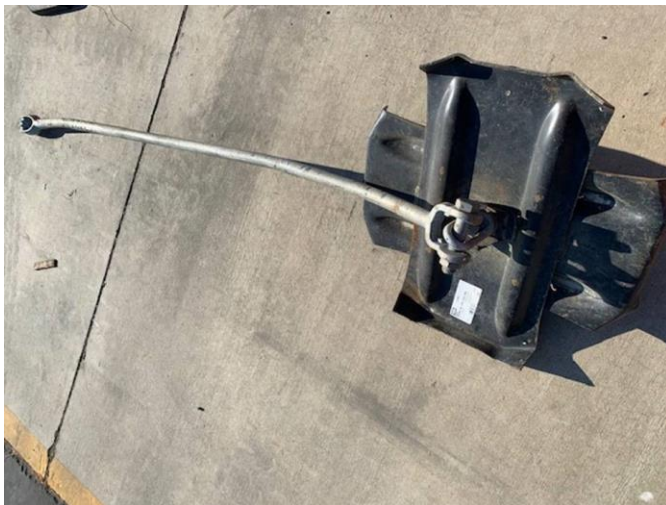
A 6' extension rod connected directly to a plate anchor utilizing an I-bolt

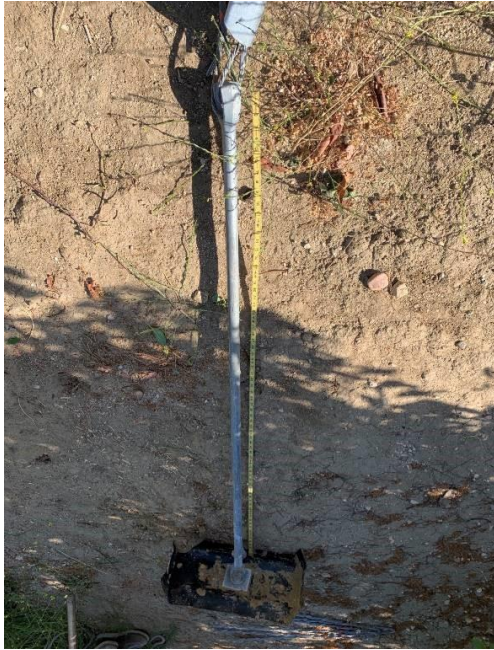
A 6' extension rod connected to plate anchor

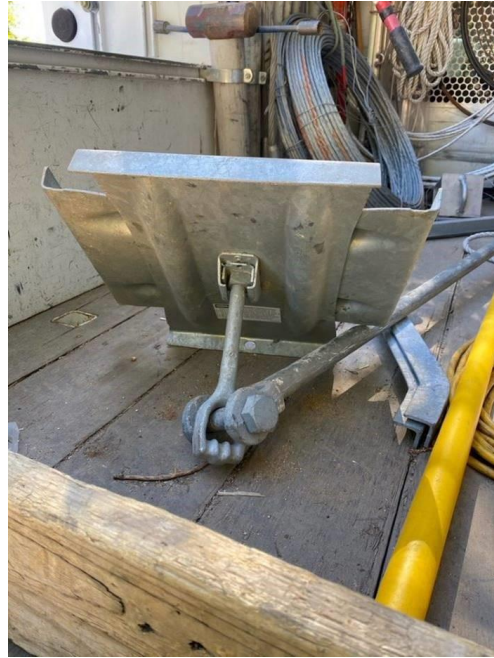
6' extension attached to modified rock anchor

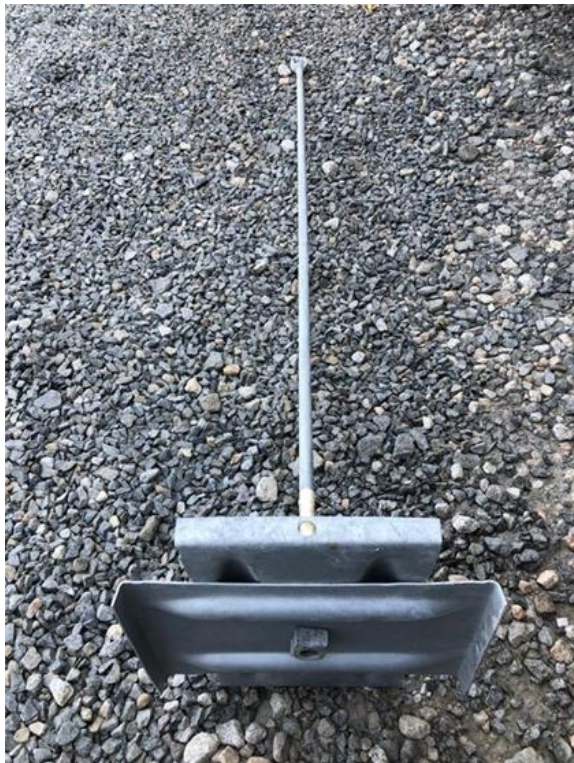
PISA with helix removed and partially threaded directly into plate anchor

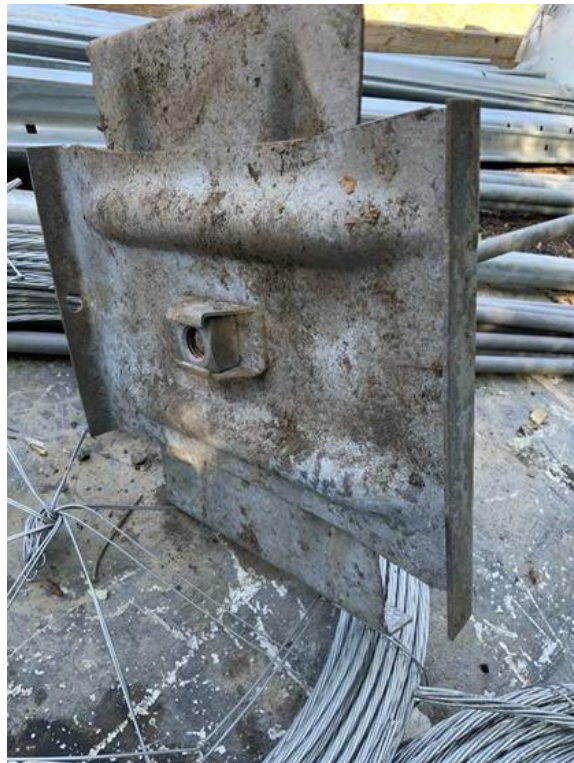
Close-up highlighting the partial threading exhibited in several of the non-conforming PISA installations

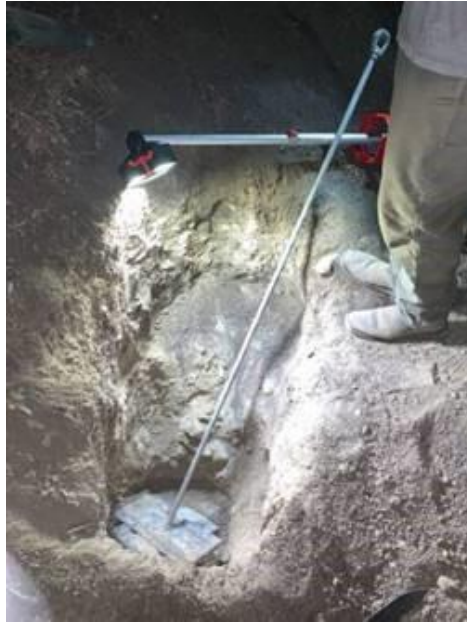
Excavation of PISA anchor directly connected to plate anchor with helix removed

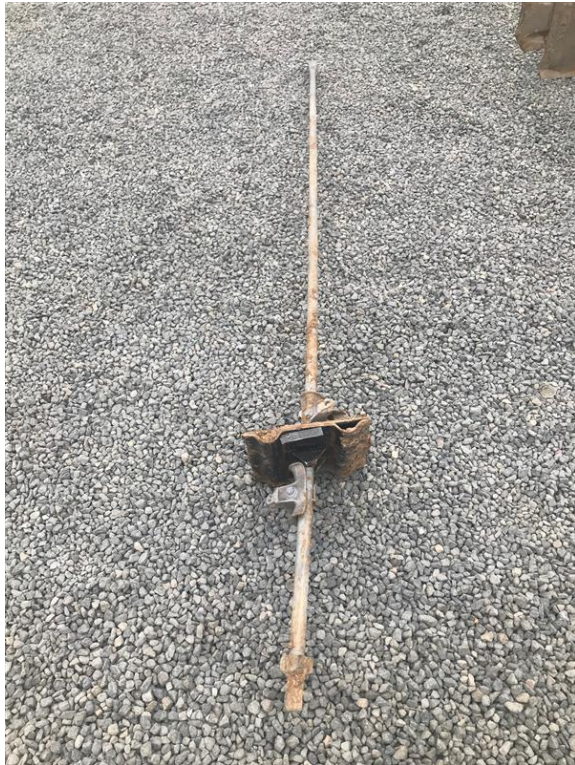
10' x 1 1/4" rod utilizing insulator clamp tops to secure plate anchor in place

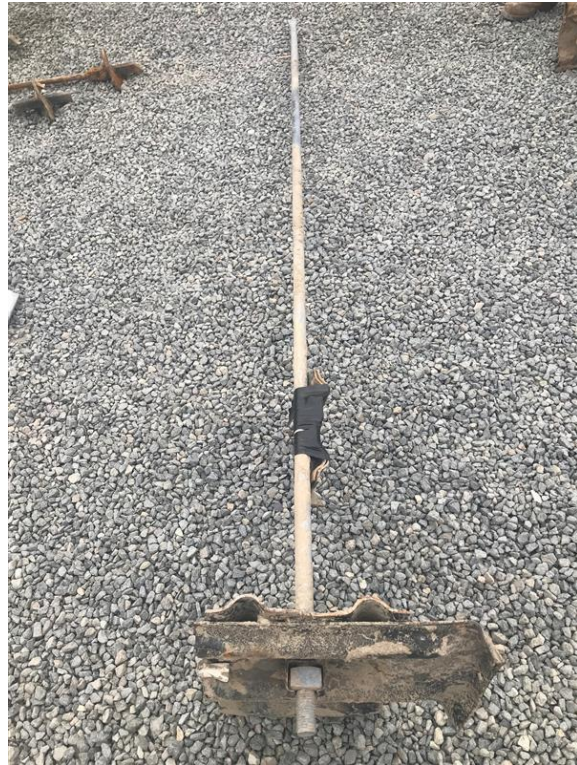
10' rod with modified plate anchor (fins cut to fit in the hole)

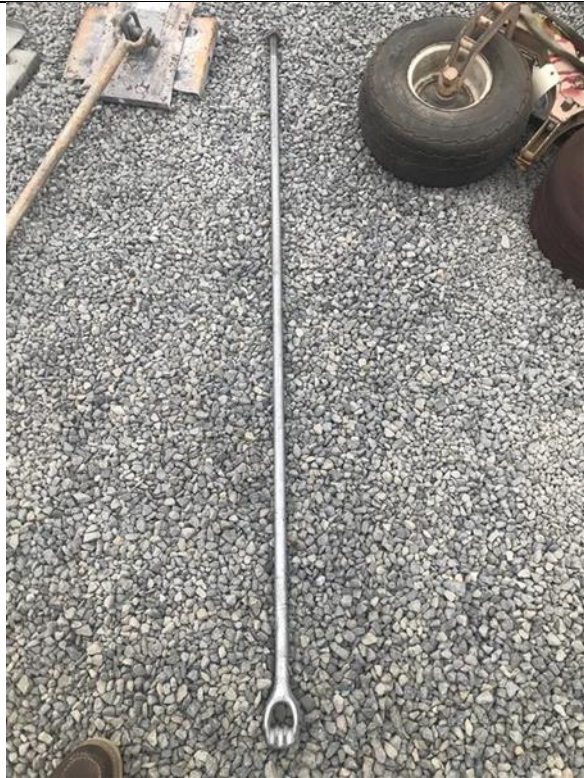
10' x 1" rod that has been cut to 79" and re-threaded

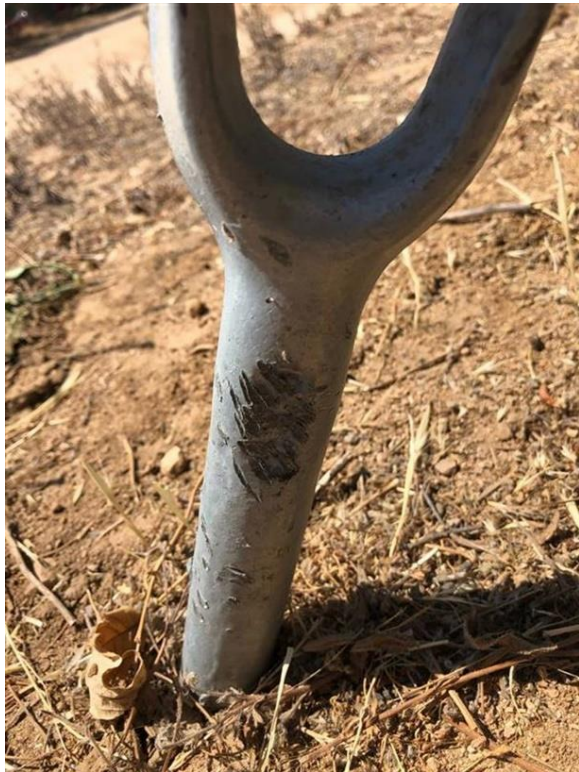
Anchor equipment with stamp ground off

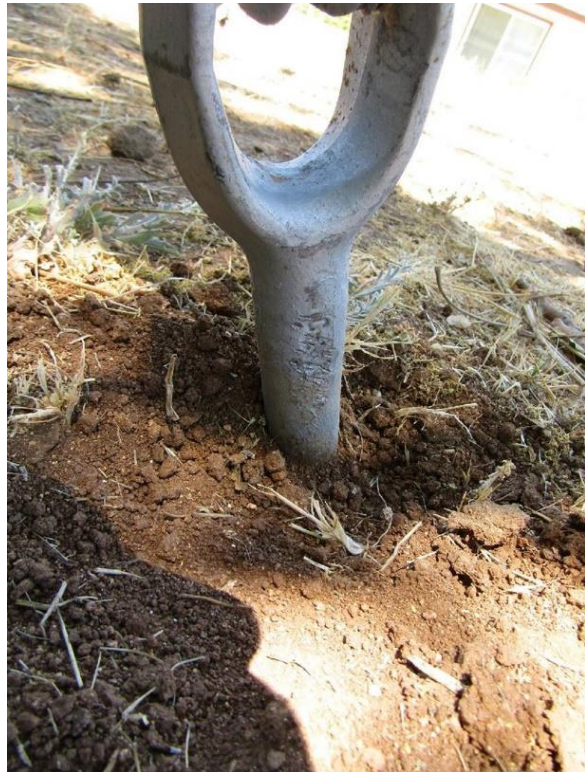
Anchor equipment with stamp ground off

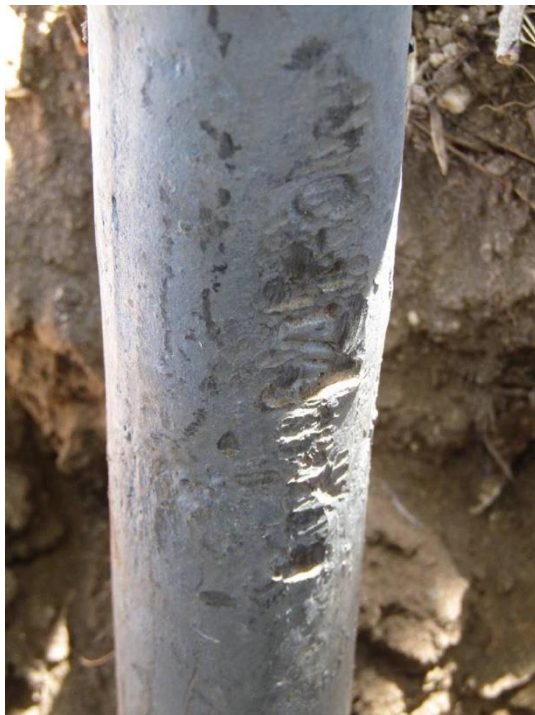
Anchor equipment with stamp ground off

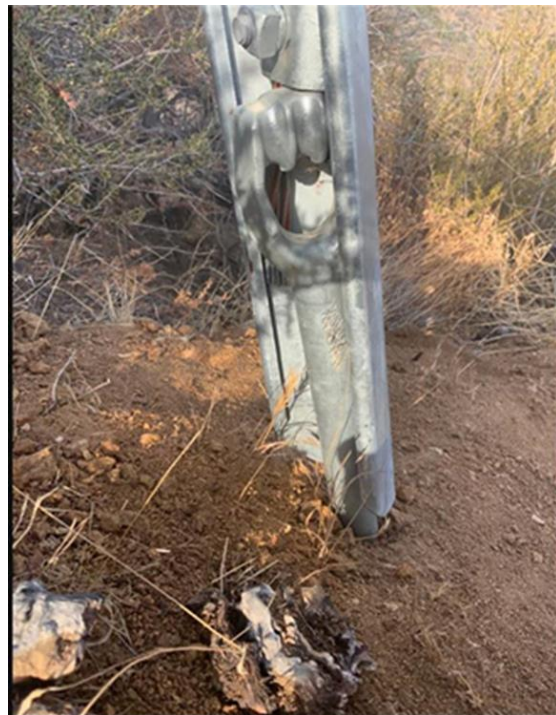
Anchor equipment with stamp ground off
