# NATF Redacted Operating Experience Report

## Bucket Truck Movement Incident

Bucket Truck Movement Incident

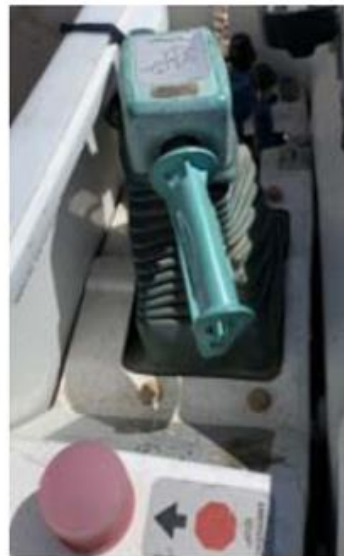
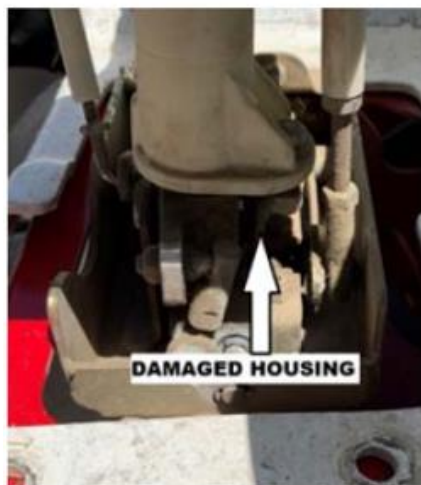
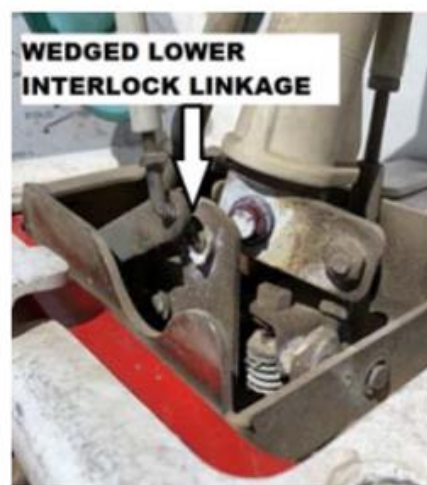
A four-man crew was tasked with replacing a conductor span and guy wire. The new conductor was pulled into place using a 5" block on a fiber sling attached to the pole. The tension was pulled from the ground using a pickup and a bull line. After the wire was near sag, the lineman moved into position to begin dead ending at the pole. Once in position, he called to the ground help to slack off on the tension. When the wire began to slack off, the bucket began to swing without the safety rigger being depressed, resulting in the lineman being pinched between the back of the bucket and the secondary conductor. As a precaution, the lineman was transported to urgent care for observation. The lineman was treated and released that afternoon with no significant injuries or work restrictions.

1. Unidentified material contacted and damaged the safety mechanism of the iso-grip and caused the unintended movement of the boom.
2. The pivot feature of the double bucket truck allowed the iso-grip on the secondary platform to be exposed to the workspace.
3. Safety mechanisms built into the equipment should be tested daily, at a minimum.
4. Potential hazards must be always be considered when positioning the bucket in the work zone.
5. Workers should familiarize themselves with the locations and functionality of the power take-off dump.

1. Develop and implement a plan that includes exercising the emergency stop buttons daily, verifying that all safety mechanisms are functioning (e.g., interlock trigger), and ensuring bucket controls are outside of the workspace whenever possible.
2. Implement a plan to eliminate the pivoting secondary platform with the manufacturer's replacement components.
