# NATF Redacted Operating Experience Report

Safety - Caisson Drop Accident

Caisson Drop Accident

# Transmission Caisson Drop

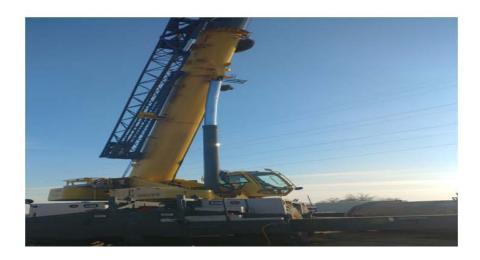
- Extensive damage to crane from 35,000 lb. caisson falling off of rigging and impacting crane.
- Significant injury caused by employee jumping from offroad 150 ton crane onto matting below.

# Damage to crane.
