NATF Redacted Operating Experience Report

Safety – Concrete Pole Accident

Concrete Pole Accident

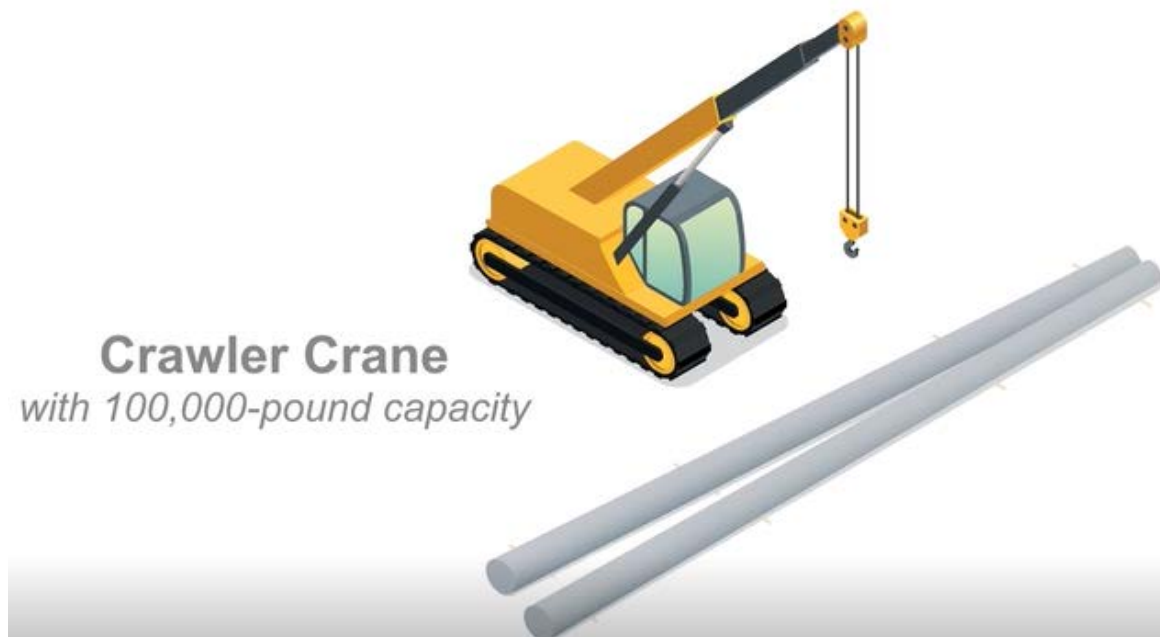
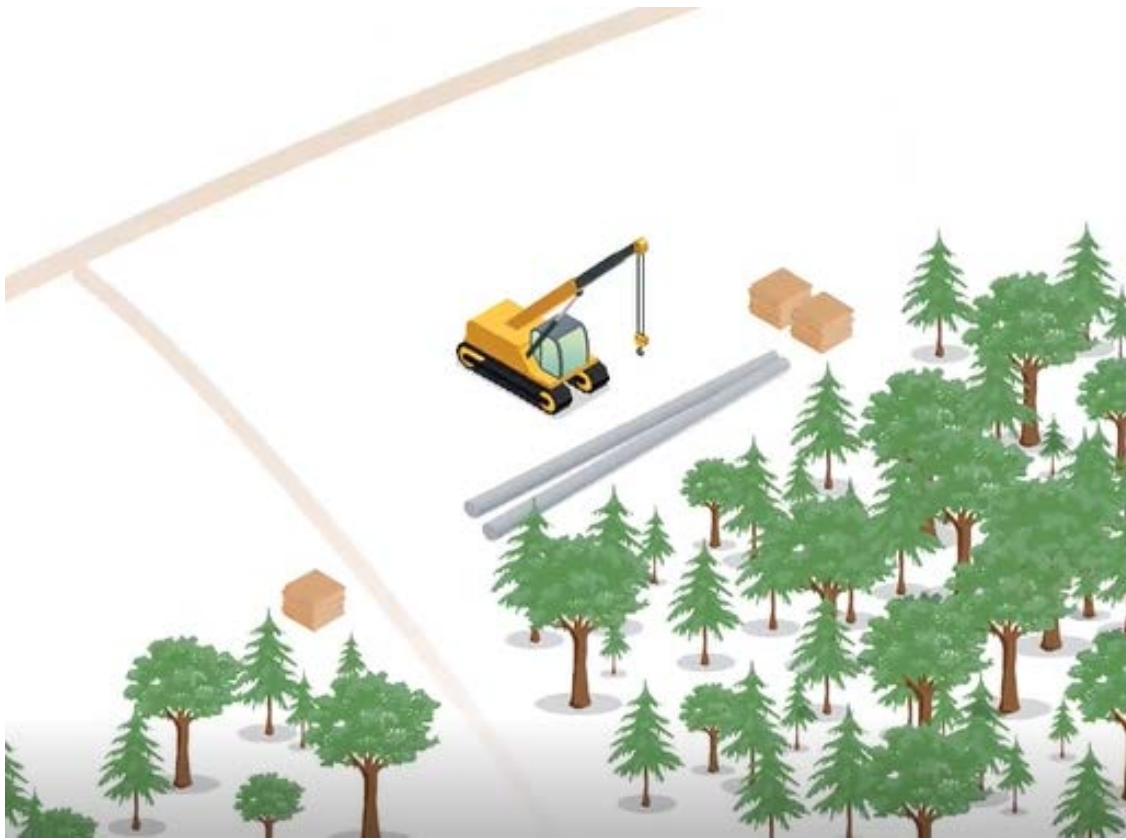
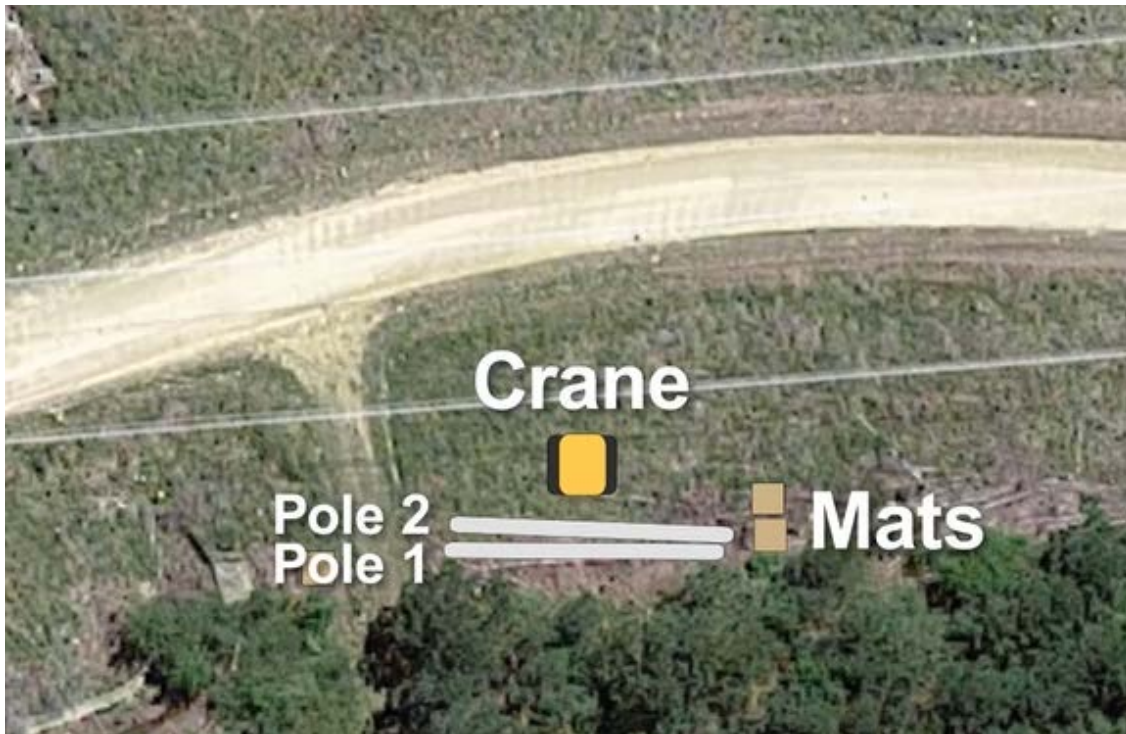
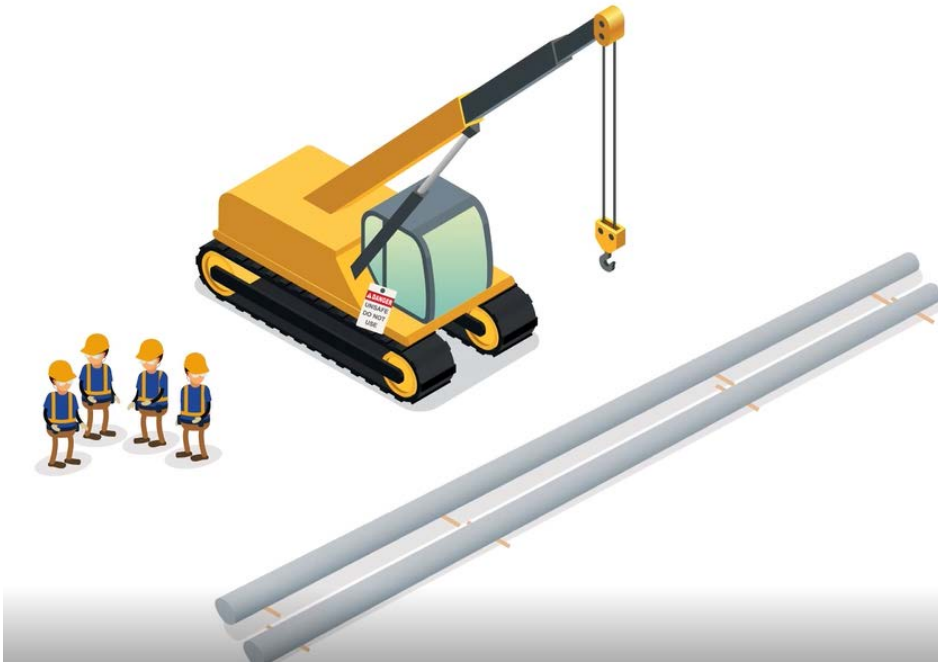
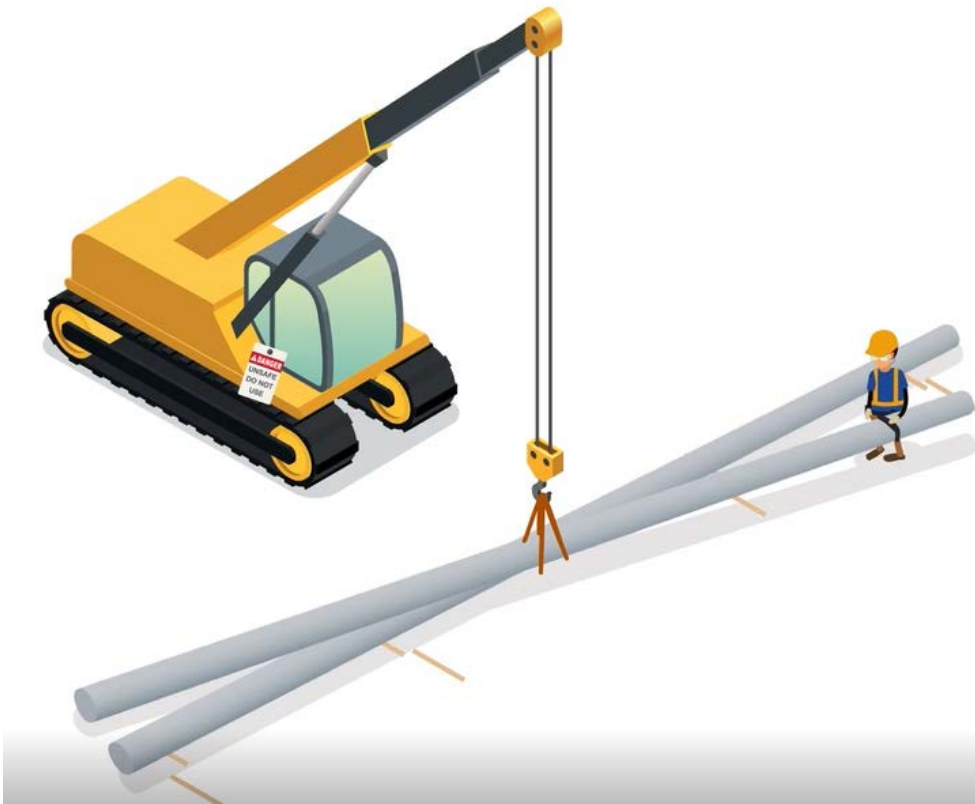
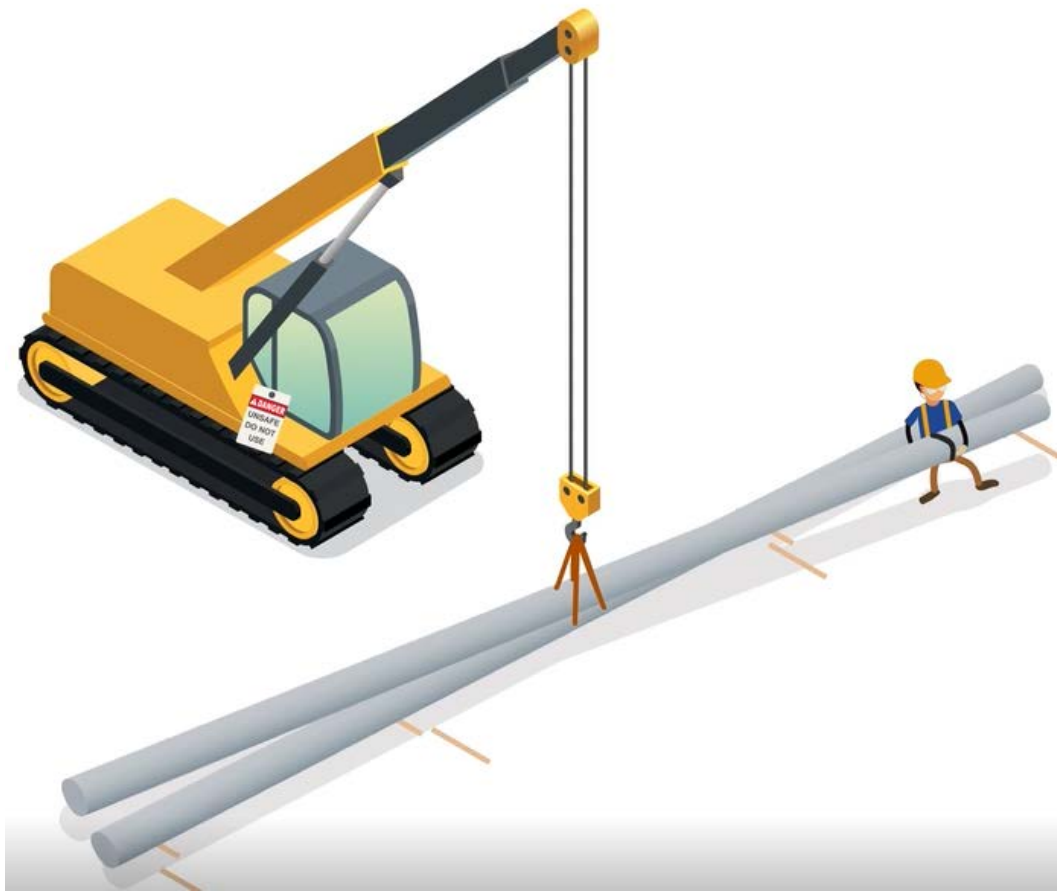
Accident Representation

The following pictures provide a representation of the accident.
