NATF Redacted Operating Experience Report

Conductor Broke When Increasing Tension

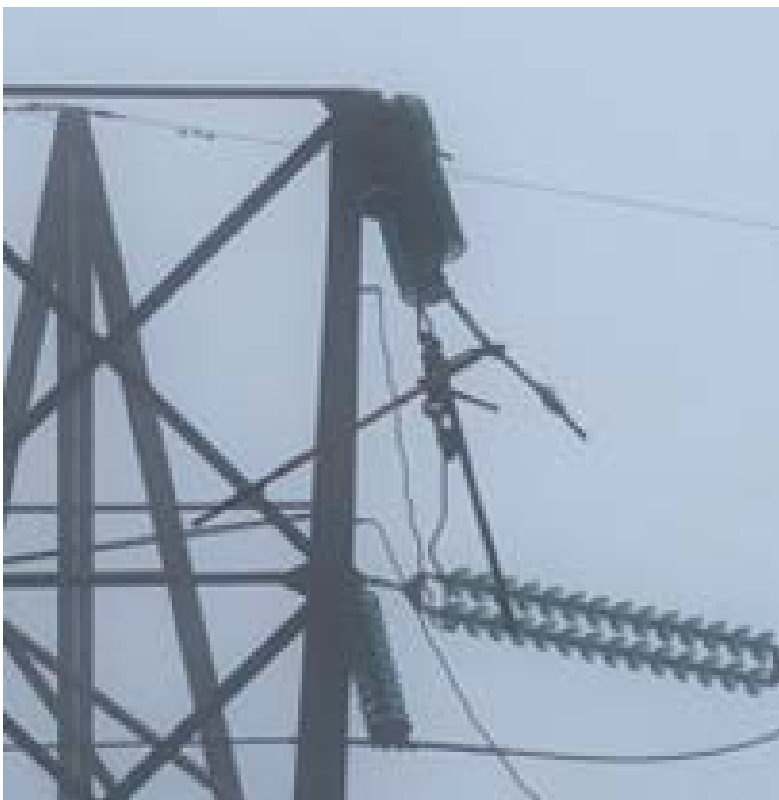
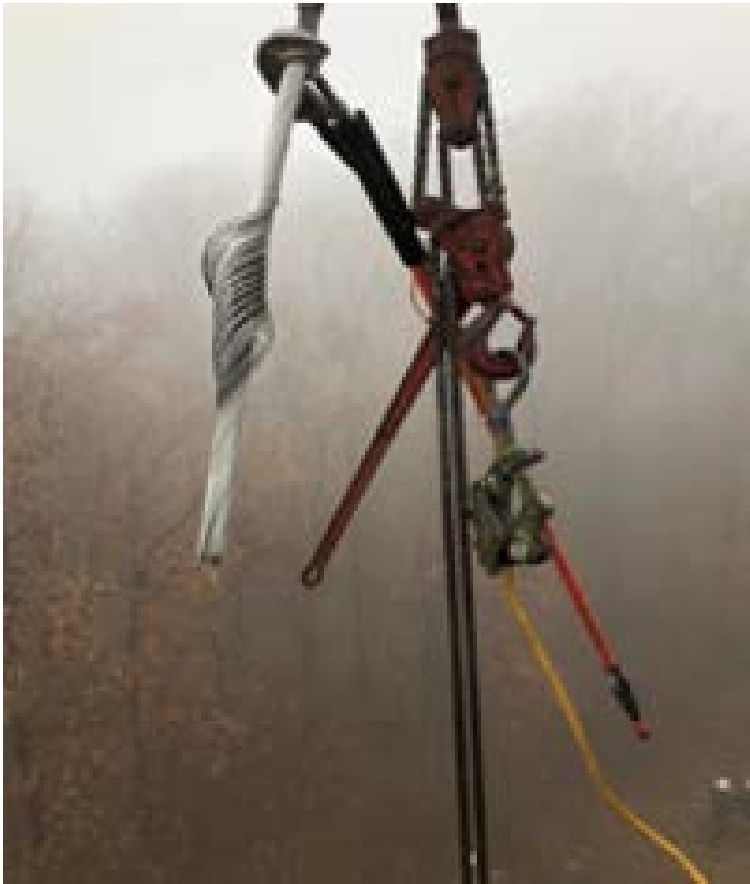
A conductor broke while a line crew was working on a 161 kV line. No one was injured.

The crew's task was to add 18 inches of slack in a span that had increased in tension due to one of the structures slowly sliding or moving over the past 40+ years. The linemen had the wire held at the dead-end structure with a 6-ton hoist and conductor grip. The crew was about to disconnect the insulator string and add the hardware for 18 inches of slack when the conductor broke near the conductor grip. The linemen were working from a bucket truck and were not positioned in the bite of the conductor when it broke.

It was determined that the conductor tension was near its breaking strength and was too high to remove with traditional rigging methods. Our company decided to hire a specialized blasting company to implode the remaining conductors from the tower.

1. Stopped work on the line and investigated the incident.
2. Worked with management to keep the circuit energized, which created heat in the conductor to reduce the actual tension until the lines could be replaced safely.
3. Coordinated with appropriate groups to ensure the remaining lines were safely removed.
