# NATF Redacted Operating Experience Report

## Electrical Contact Due to Inducted Voltage

Electrical Contact Due to Induced Voltage

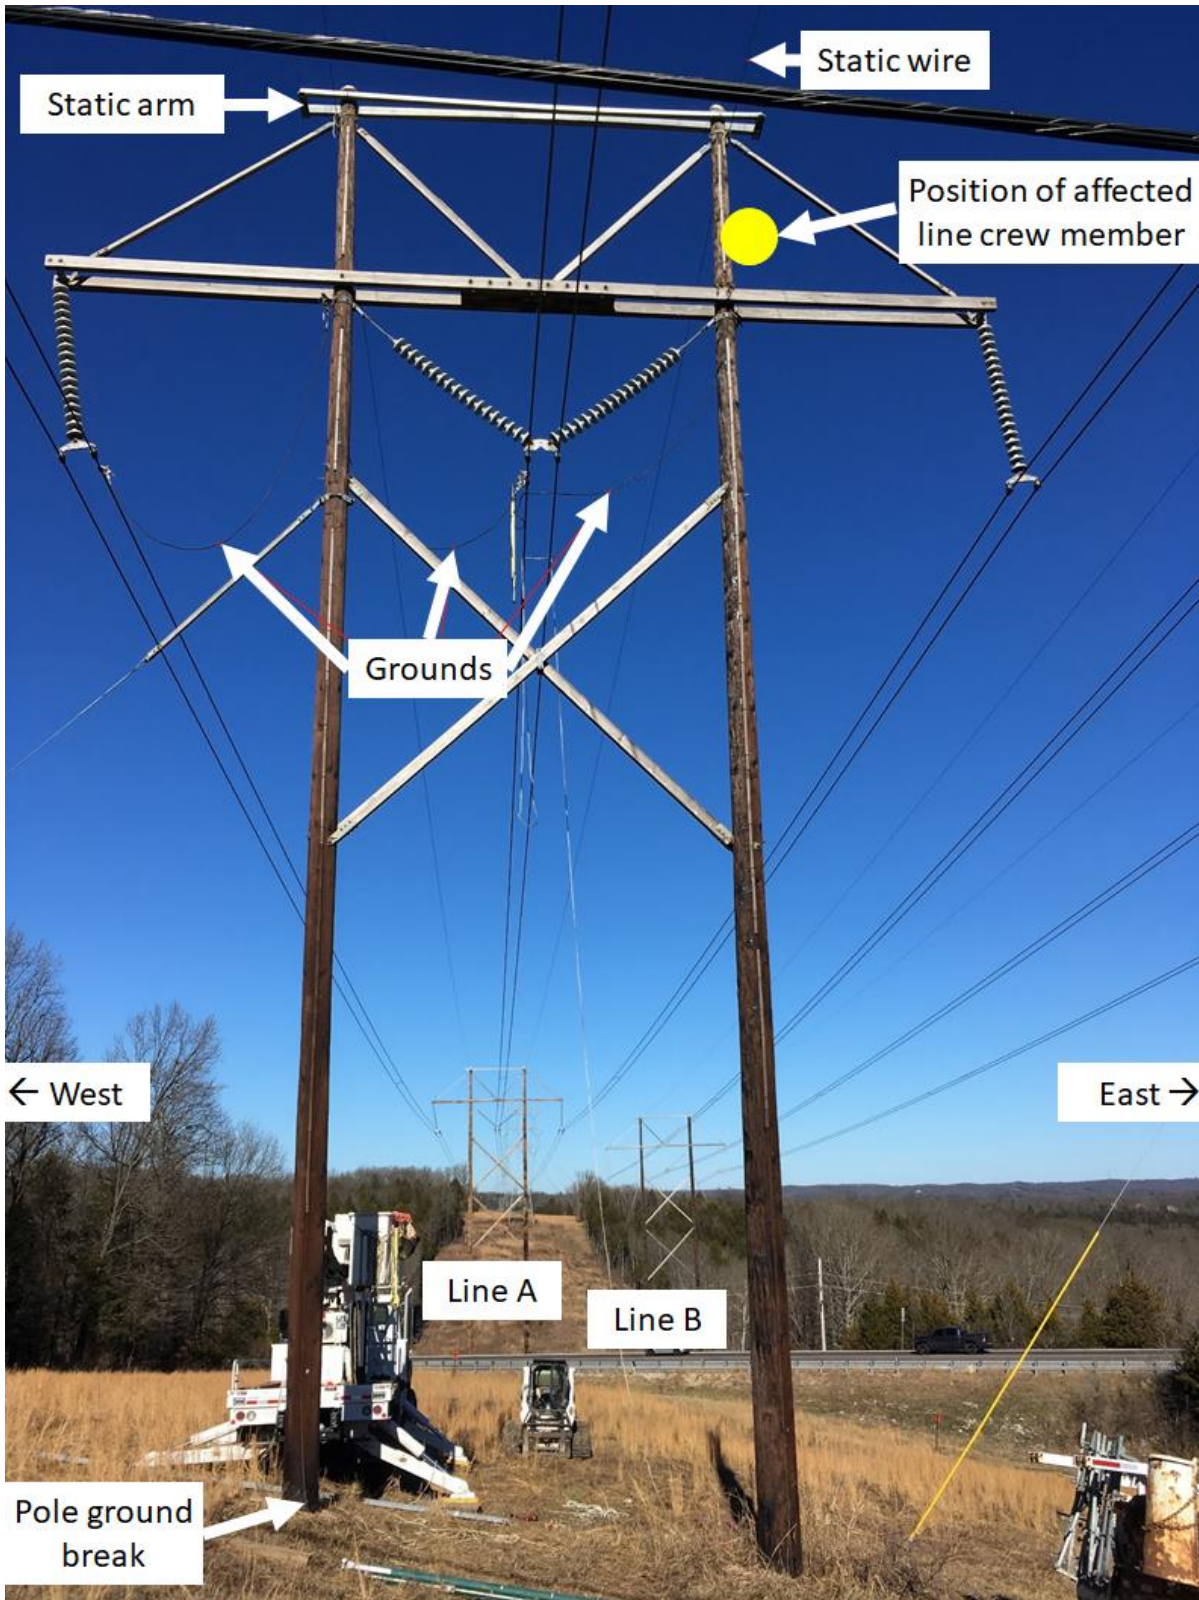
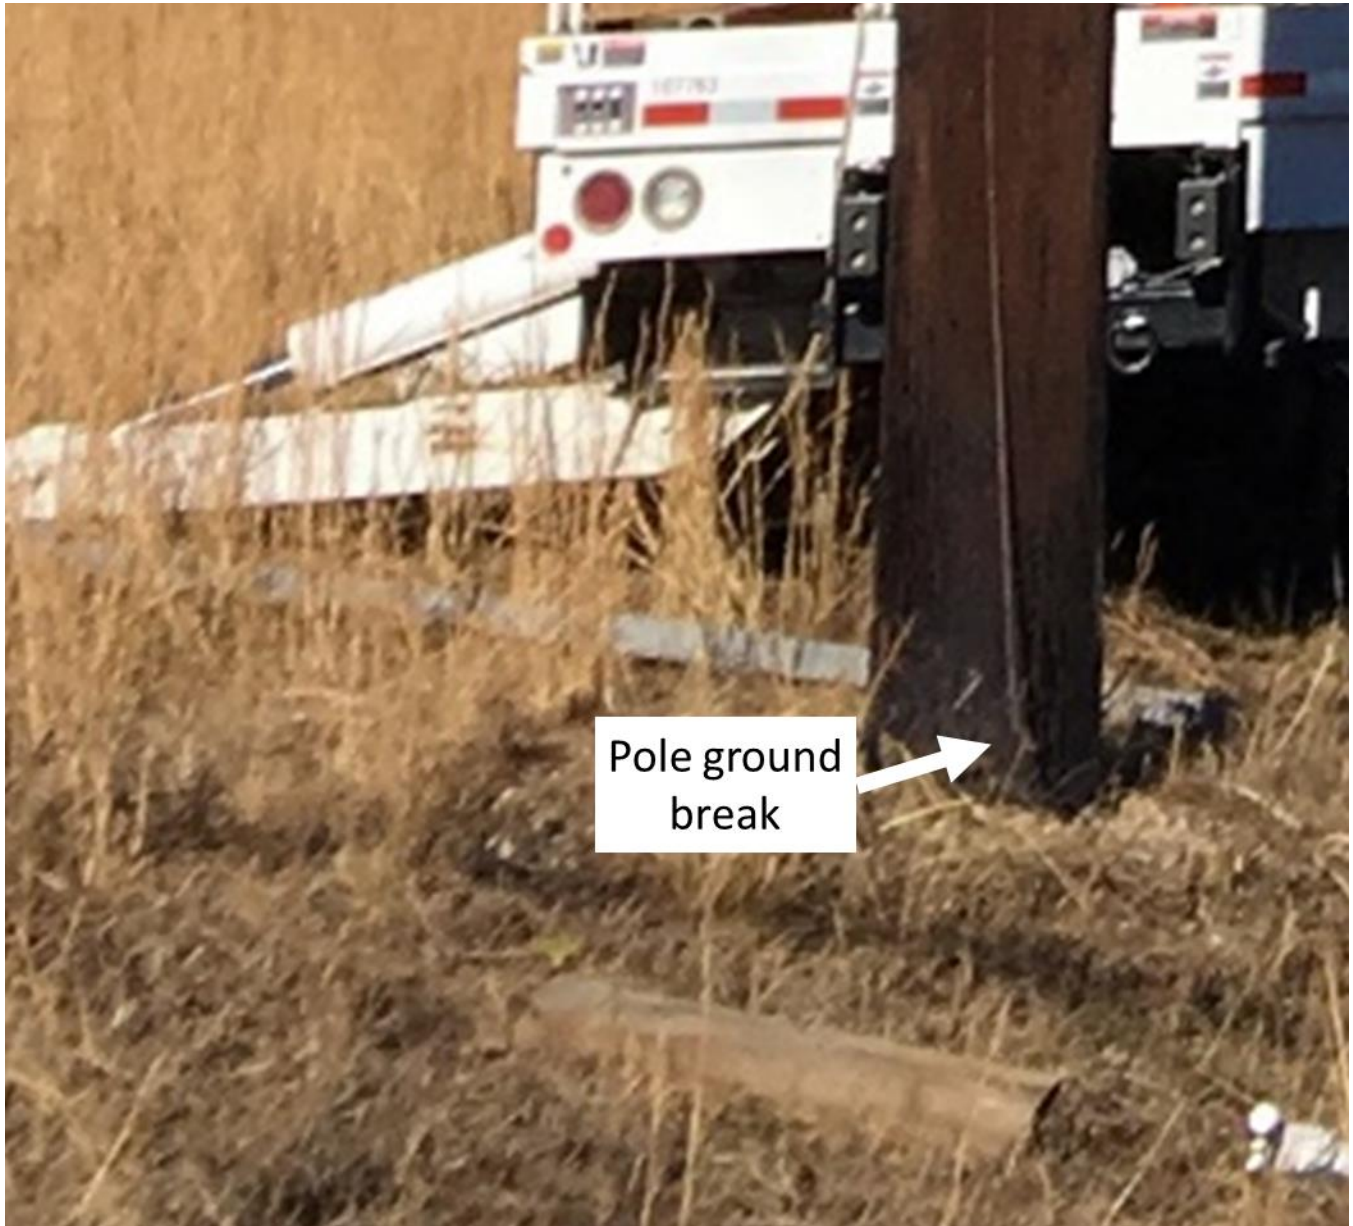
The line involved was a double circuit with another line for most of its length. This incident occurred on a point within a short section where the two lines transfer to parallel wood H-frames. See attachments for photo of the worksite.

One of line crew members needed to reposition on the pole to reattach the static wire to the new static arm. While repositioning on the pole, the individual simultaneously grasped the static arm with one hand and the static wire with the other and received an electric shock. The shock was intense enough that the individual was unable to release their grip. The crew member intentionally kicked their feet off the pole and released tension on the climbing belt to allow themselves to slide down the pole to the cross-arm position. The slide down allowed the crew member to release their grip from the static arm and static wire. The individual received the necessary medical care and returned to work.

The grounding at the worksite consisted of safety-grounds connected between two of the phases that were in the work zone and the eastern pole ground. No other safety grounds were installed at other locations along the line. The western pole ground was disconnected from the earth due to a break at the ground line. Though one of the pole grounds at the structure was disconnected from the earth due to a break at the ground line, the other pole ground was intact. Grounding was then expected to be maintained through the safety-grounds connecting the phases to the unbroken section of the west pole ground to the static arm and then to the intact east pole ground. The crew was aware of this during the pre-job brief.

When the static wires were disconnected from the static arm and secured to the poles with ropes, this electrically isolated the structure being worked from the multi-grounded system. The only ground in play to shunt the induced voltage on the conductors for line A was the individual east pole ground at the structure. When the line crew member grasped the static arm and static wire, that individual and the multi-grounded static wire became electrically connected in parallel with the individual pole ground at the structure being worked.

1. Develop, document, and disseminate grounding requirements for working on normally de-energized components to all affected employees.
2. Bond all conductors and wires to the same ground system to create an equipotential zone around all coworkers exposed to potentially energized components.
3. Develop and enhance standard work practices.
4. Provide training on updated safety documentation and standard work practices.
