NATF Redacted Operating Experience Report

Electrical Contact Incident during Underground Cable Replacement

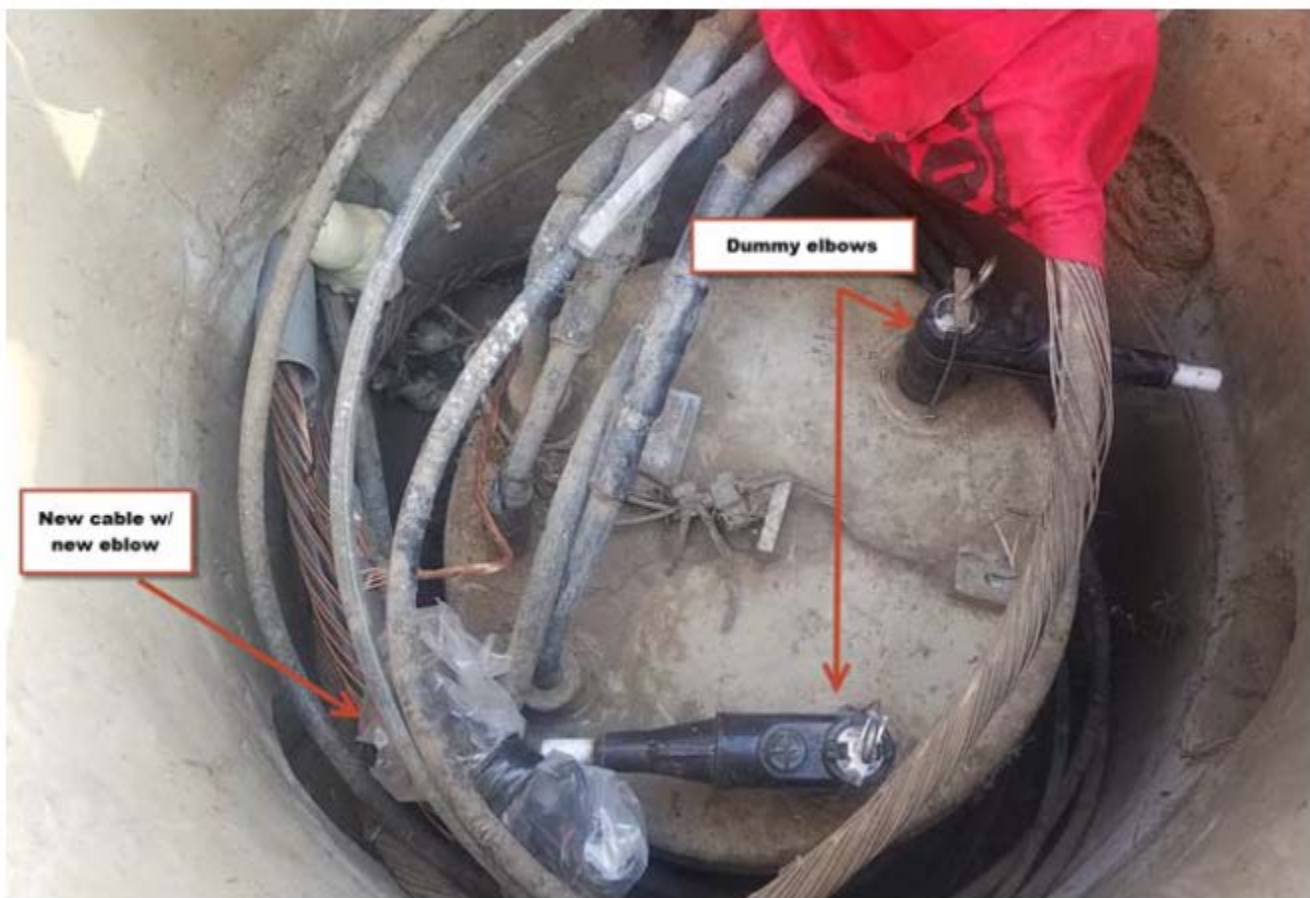
Associated Picture

While waiting for the replacement linemen, the foreman and groundman remained at the job site and began to prepare the site for the replacement linemen by making up the elbow on the end of the cable that was laying outside of the transformer. After making up the elbow, the foreman began coiling new primary cable and determined he needed to climb inside the BURD transformer enclosure. He utilized a hot-stick to free the cable from the secondary conductors. While working from atop the transformer, the foreman made inadvertent electrical contact. He sustained significant burn injuries to his hand, arm, and leg. The foreman was eventually able to return to work.

This incident had two apparent causes and one contributing cause. Apparent cause 1 was the loss of focus on safe work practices; instead, the focus was placed on productivity. Apparent cause 2 was that the accepted work practice used did not mitigate the hazard. The contributing cause was the decision to continue working without waiting for the other linemen to arrive.

1. Implementing a job aid for connecting generators to BURD transformers that will eliminate the hazard when applicable.

2. Communicating the causes and key takeaways from this incident to field personnel, including contractors.
3. Incorporating a case study for this incident into new-hire lineman/groundman training.
