NATF Redacted Operating Experience Report

Failure of 138 kV Vee Switch

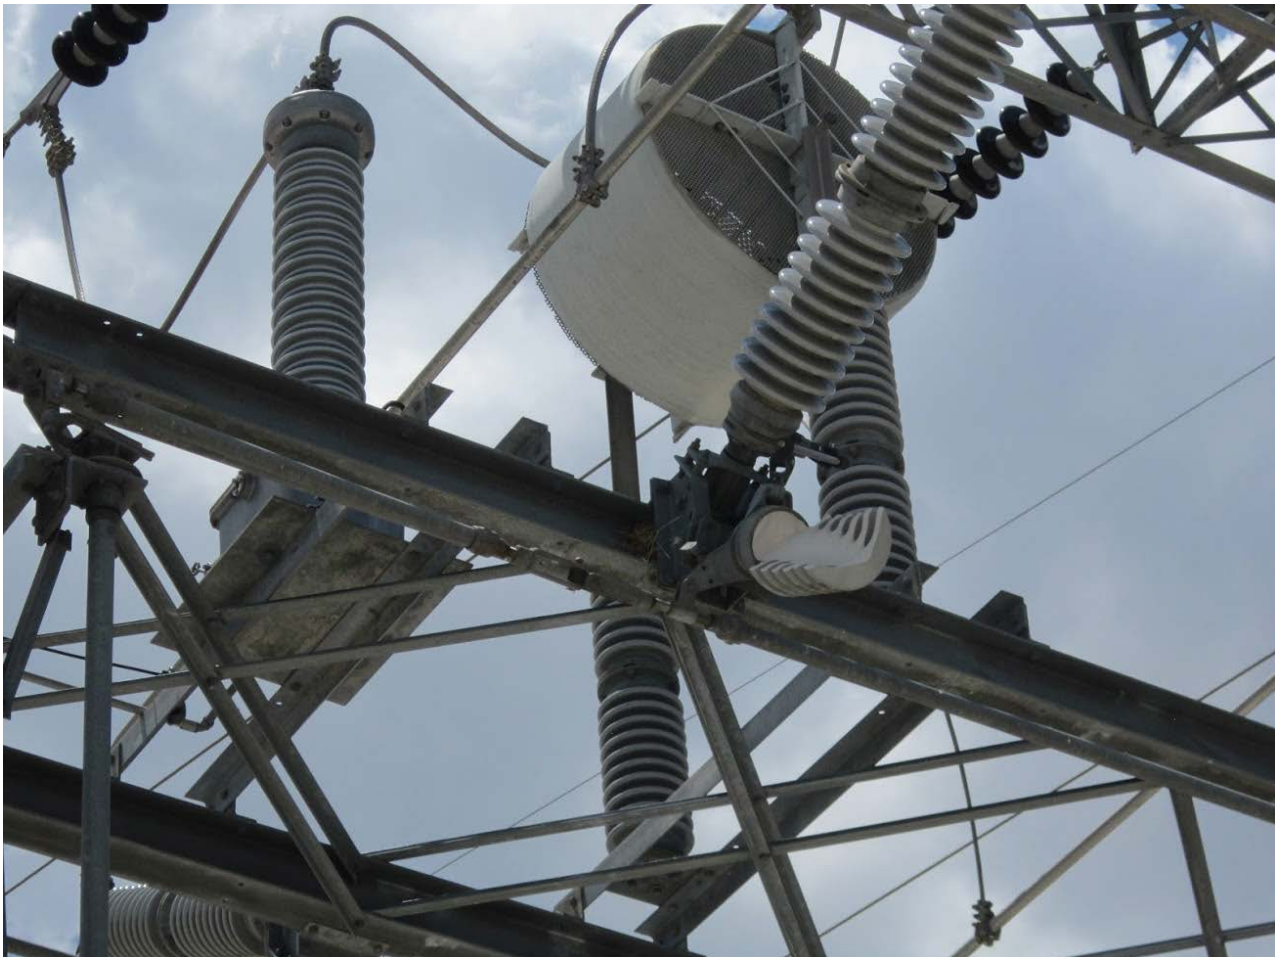
An employee was opening a 138 kV gang-operated vee switch when one of the insulators failed. A pipe buss and half of one phase of the switch fell to the ground. The pipe and insulator fell in the clear, but nearly struck the employee operating the switch.

The investigation into this failure was not conclusive. Possibilities for the failure include:

- Pre-existing damage from installation, shipping, or manufacturer's defect
- Age or environment
- Cantilever stress induced by the weight of the insulator itself

Figure 1. Remainder of Failed Vee Switch

1. The other phases of the failed switch were replaced due to the similar age, installation, and manufacture.
2. The gang mechanism has been redesigned so that the handle is not directly underneath the switch itself.
3. The failed components have been shipped for further inspection.
4. Employees performing monthly substation inspections have been notified of this event. Each has been issued a pair of high-resolution binoculars to aid in the possible detection of small cracks in substation insulators.
5. This failure has been shared with all transmission services employees and circulated to our transmission customers who may own similar equipment.

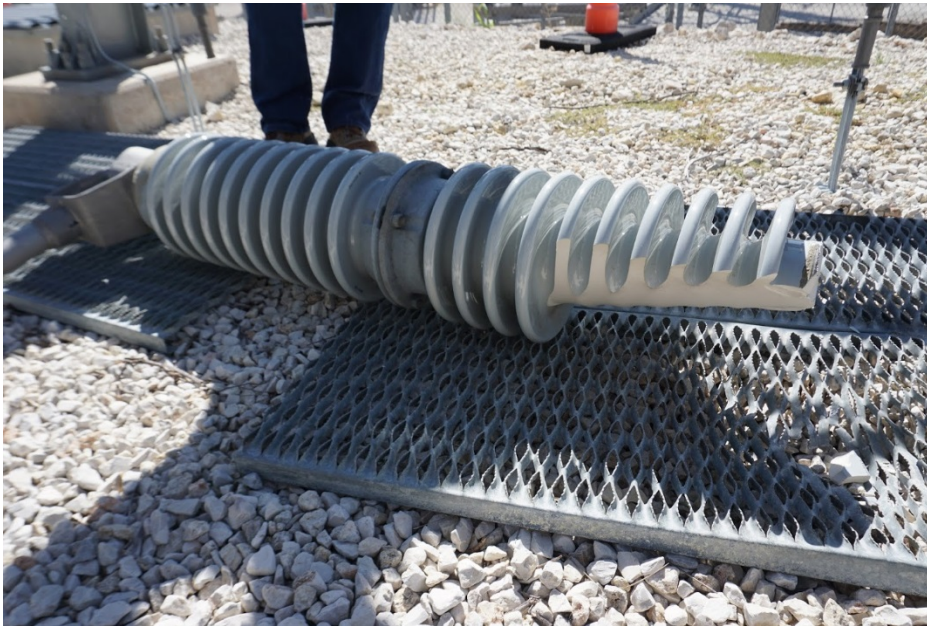
Figure 2. Portion of Failed Insulator and Buss that Fell to Ground
