# NATF Redacted Operating Experience Report

Safety – Improper Installation of Safety Grounds

Improper Installation of Safety Grounds

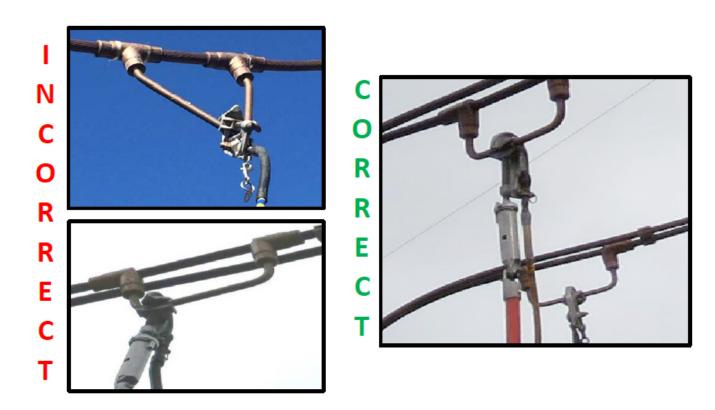
While performing a routine 161 kV circuit breaker test, a crew observed loose safety grounds. The safety grounds were applied near the bend of the grounding stirrups (where the resting weight may cause the safety ground to go during attachment). One corner of the temporary ground clamp was tightened in the bend and not completely flat on the ground stirrup. After slight vibration, the clamp slid out of the bend and became loose.

1. When using grounding stirrups, the temporary safety ground should be attached in the middle of the flat portion of the stirrup and away from any bends.

- Shared this OE with transmission construction and maintenance personnel
- Shared this OE with NATF
- Issued a "Transmission Notice" to address the improper installation of existing grounding stirrups
