NATF Redacted Operating Experience Report

Safety – Lowering Material Injury

Lowering Material Injury

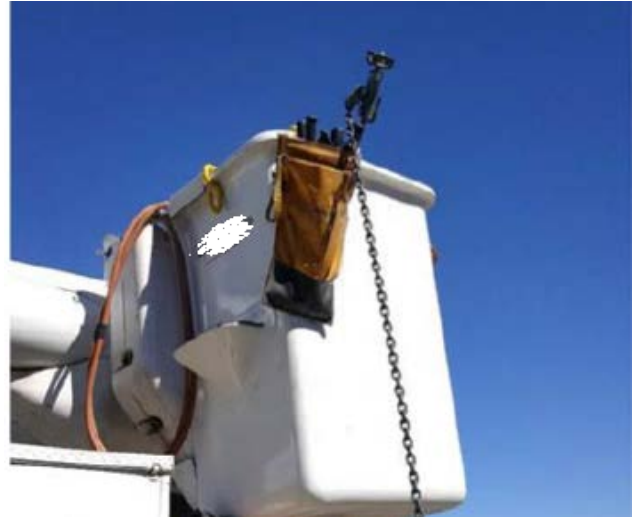
A crew had completed work for the day and was removing grounds from the pole. The crew had the three sets of grounds in the bucket and placed the pole band in a cutter bag hanging on the outside of the bucket as a means to get it and the other material to the ground (see figure 1 for an example). Simultaneously, the apprentice lineman was coiling up the grounds beginning with the ground rod. As the linemen descended, the apprentice lineman moved underneath the bucket. When the pole band fell, the apprentice linemen was in its direct path. The apprentice lineman was wearing a hard hat, but still sustained an injury; he was able to return to work within two weeks.

Figure 1. Example of how the pole band was placed

1. Secure materials before raising or lowering the bucket.
2. Get confirmation from overhead workers before entering the area underneath overhead work.
3. Do not go into the area underneath overhead work unless necessary; ask yourself if the task can be done at a later time.

- Communicating management's expectation through crew meetings, tailboards, and internal media.
- Following up using the safety observation program on actual behavior in the field.
- Memorializing the communication expectation in our Accident Prevention Manual.
