NATF Redacted Operating Experience Report

Stored Energy Hazard in Bushing Capacitors

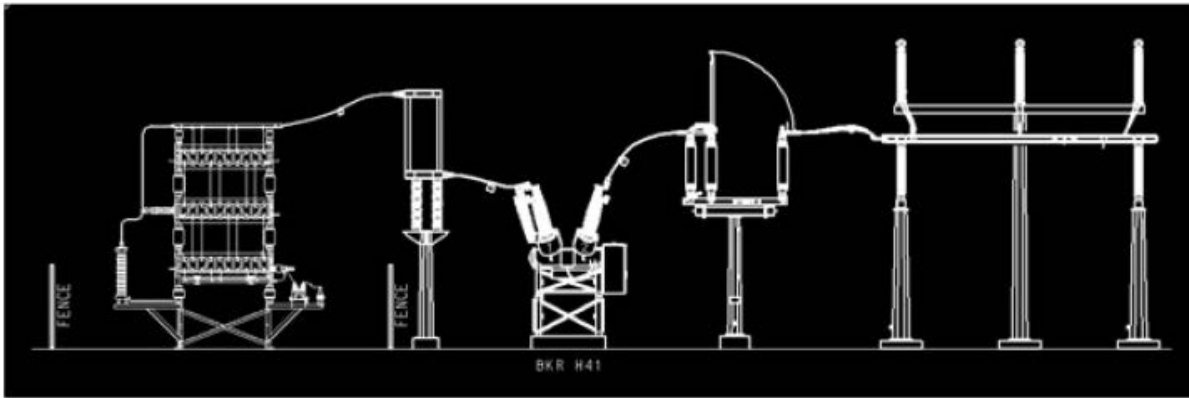
Initial Condition

1. The leads were removed between the circuit breaker and the reactors prior to energization in order to test the breaker. The capacitor bank and reactors were intentionally disconnected so the breaker could be independently energized.
2. The breaker was closed and energized for 10 minutes to prove proper dielectric operation. See attached "Breaker Energization" figure.
3. The breaker and disconnect switches were opened and grounds were installed so the leads could be re-attached. With the breaker open, the bushing shunt capacitors remained charged. See attached "Post-Energization – Capacitor Charged" figure.
4. As the electrical worker went to reattach the lead on bushing number one, he touched the bushing top while holding the lead in his right hand. This created an electrical path to ground, causing the capacitor to discharge and shock the electrical worker.

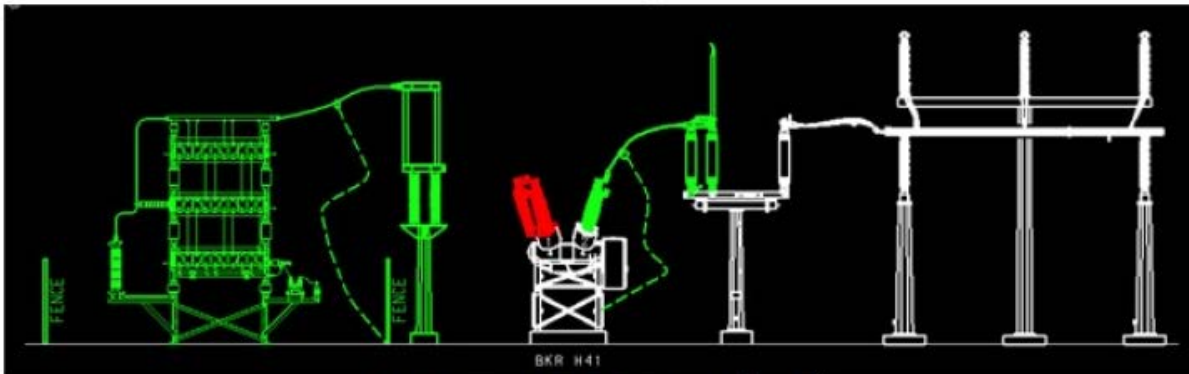
Post-Energization - Capacitors Charged

5. Electrical worker had grounds on both sides of work area, but the breaker was open. He failed to recognize that the capacitor was not grounded. Never ground through a breaker. Always test for dead. Always ground conductors.

2. Requested that the breaker manufacturer provide warning signs and a grounding point for the capacitor. Signs have been placed on existing in-service breakers. The manufacturer will make available a retrofit kit for our in-service breakers. Our company revised breaker specifications to require signs and ground points. The manufacturer will revise its documentation to illustrate the hazard and provide guidance on how to safely discharge and ground the equipment.
3. Existing breakers with bushing capacitors were identified and flagged.
4. Design group revised work procedures to afford additional oversight and review time for initial energization procedures.
