NATF Redacted Operating Experience Report

Substation Employee Fall Incident

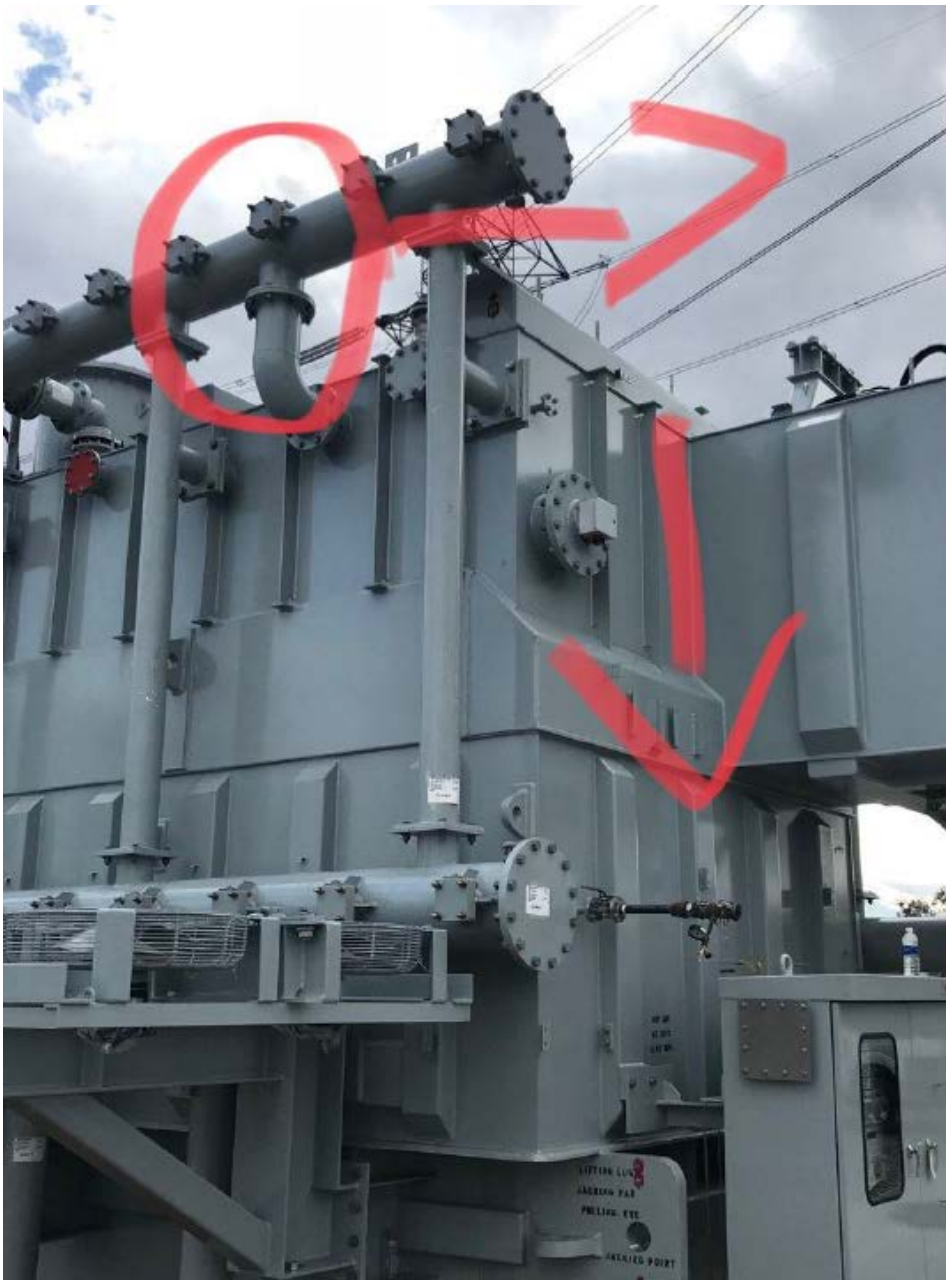
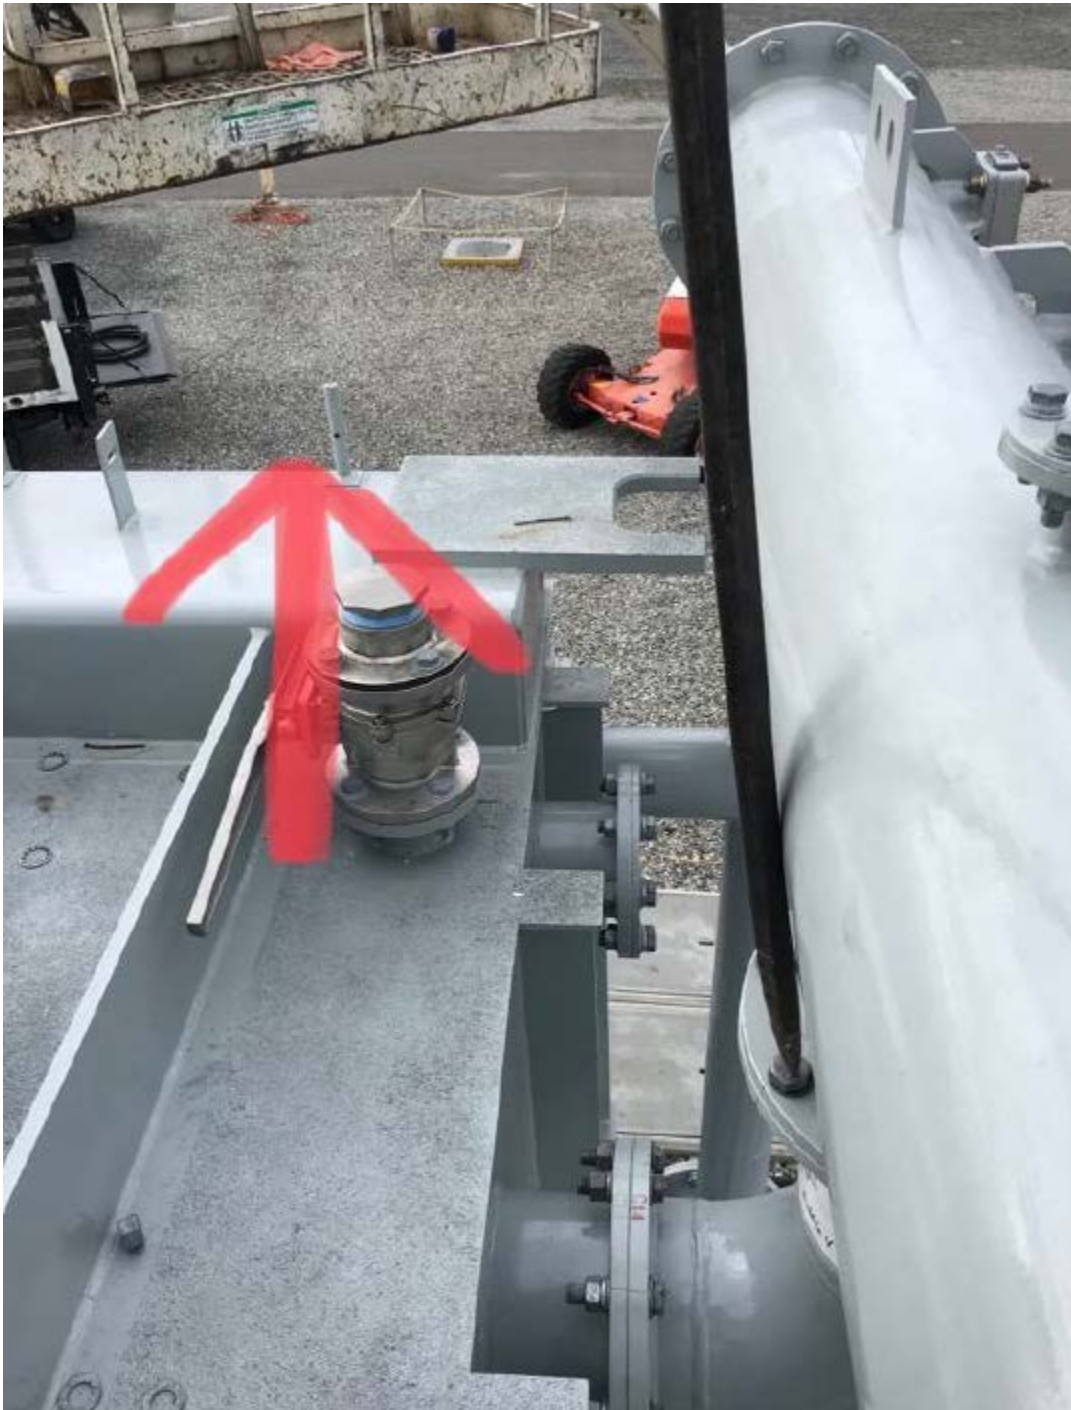
Photos from Incident

An employee was seriously injured when he fell approximately 16 feet from the top of a transformer. The employee was attempting to align a manifold elbow flange when he lost his balance and fell to the ground. Though the injured employee was wearing a fall protection harness and lanyard, it was not attached to the transformer when the incident occurred.

The employee lost his balance when the tool he was using slipped out of a flange bolt hole while significant lateral force was being applied. The length, diameter, and taper of the tool in combination with the bolt hole diameter resulted in the tool being susceptible to slipping out of the hole when lateral force was applied due to insufficient pressure in the flange.

1. Work practices and expectations established to ensure fall protection lanyards are attached and formal peer check is used (3-way communication) by personnel working on top of transformers.
2. Conducted a formal job hazard analysis for working on top of transformers.
3. Identified and procured suitable tool for aligning flanges associated with transformer auxiliary systems.
