NATF Redacted Operating Experience Report

Vehicle Fire Caused by Propane Torch

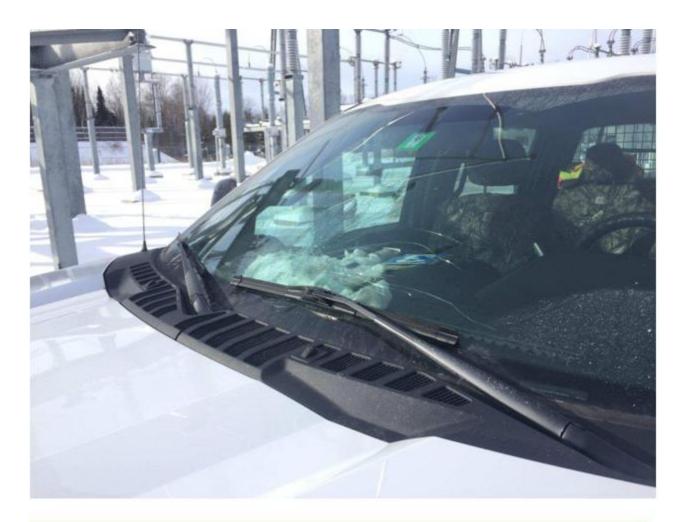
A disposable propane torch was being used to thaw an air line on a breaker within a substation yard. The torch stopped working because of the cold ambient temperature (estimated to be -11°F), which condensed the propane. The torch (bottle and nozzle) was turned off and placed on the dash of the truck with the heater on, for the purpose of thawing and expanding the frozen propane gas. A small fire resulted, which was immediately extinguished with snow. A fire extinguisher was available but was not required. No injuries or impact to customers occurred.

View of the burned area of the truck dashboard. Snow was used to extinguish the fire.

- 1. Propane torches should not be placed on the dashboards of vehicles.
- 2. Thawing propane cylinders on dashboard heating vents is not a good practice and should not be used in the future.
- 3. Housekeeping of vehicle dashboards/interiors was considered a contributing factor.
- 4. Propane torch tips need to cool completely before being left unattended and must be kept far away from combustibles.
- 5. Training and protocols regarding the proper storage and use of propane bottles are critical for all employees using these tools.

- 1. Crew extinguished the fire and removed the propane tank from the truck cab to establish a safe environment.
- 2. Initiated a work stand-down removed the vehicle from service for repair.
- 3. Performed a "learning opportunity" review with a field-staff team; also reviewed and shared the NATF redacted OER-366 "Disposable Portable Propane Tank Storage" report.
- 4. Implemented corrective actions including (a) training for personnel and (b) brass caps with O-rings were acquired for use during storage.
- 5. Communicated all results with other personnel.
- 6. Considering alternative methods, such as heat guns, to thaw/heat frozen devices.
- 7. Brass caps with O-rings were issued to be used when the tank is in storage.
- 8. Propane storage and usage will be included in new training programs.
