# NATF Redacted Operating Experience Report

## Circuit Breaker Tips Over during Disassembly

Circuit Breaker Tips Over during Disassembly

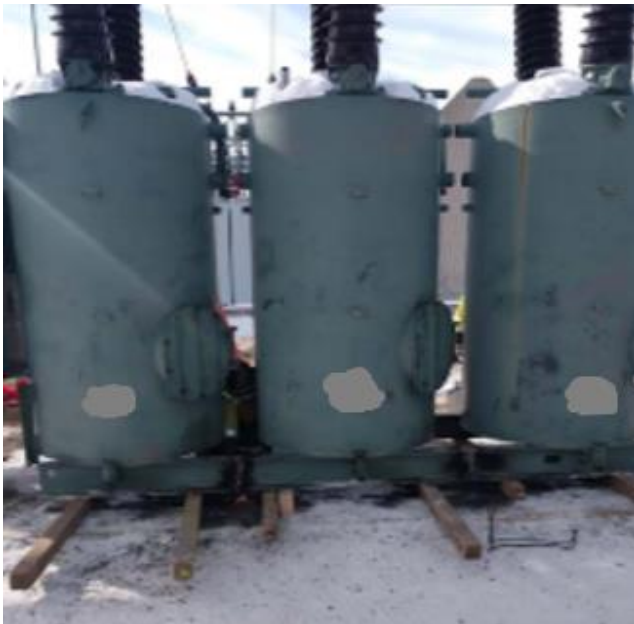
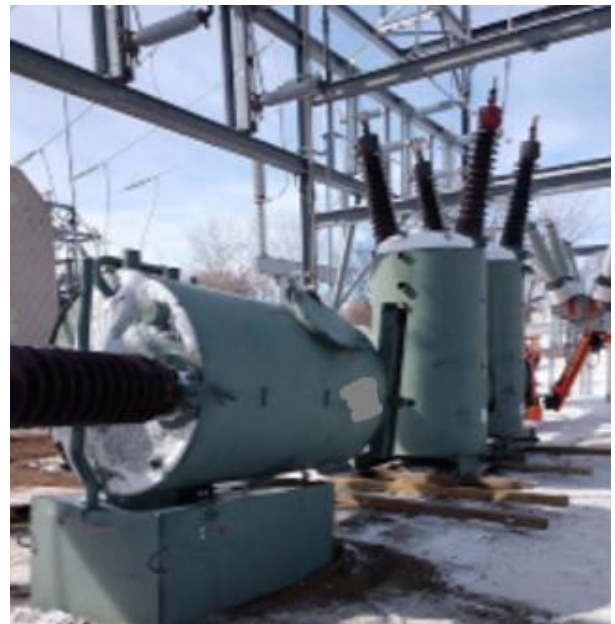
When removing a 1960's vintage circuit breaker from inside a tight area in a substation, it is often necessary to cut the breaker apart and remove it piece by piece. In this instance, the tank with the control cabinet attached was cut off, and the weight of the control cabinet pulled the tank over. There were no injuries from this incident, and no damage was done to any other equipment.

1. Remove the control cabinet first, then cut the rest of the circuit breaker apart.
2. Block underneath the control cabinet to prevent it from tipping over.

1. This incident was reported as a near miss and shared internally with all transmission employees.
2. Implemented steps to review tasks associated with performing this job (before starting work) to ensure safety of personnel and reduce risk of damage.
