# NATF Redacted Operating Experience Report

Safety - Caisson Drop Accident

Caisson Drop Accident

# Transmission Caisson Drop

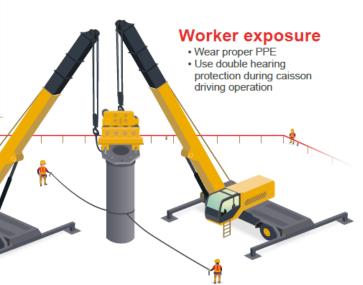
# Material falls during lift

- Set up the worksite to ensure positive controls are maintained such as grapple crane or crane with rigging at all times.
- Inspect slings and rigging prior to use.
- . Do not use quick connect rigging, until the caisson is set.
- . Do not use the hammer without the grapple.
- · Pick up caisson from side opposite other operations.
- · Use tag line or push sticks to control load.

Barricade failure zone, load travel path, and landing area.
Maintain safe distance (greater than caisson length) during lift.
Do not stand beneath boom or hammer.
Use trained signallers.
