# NATF Redacted Operating Experience Report

## Cutting DC Cable While Energized

Cutting DC Cable While Energized

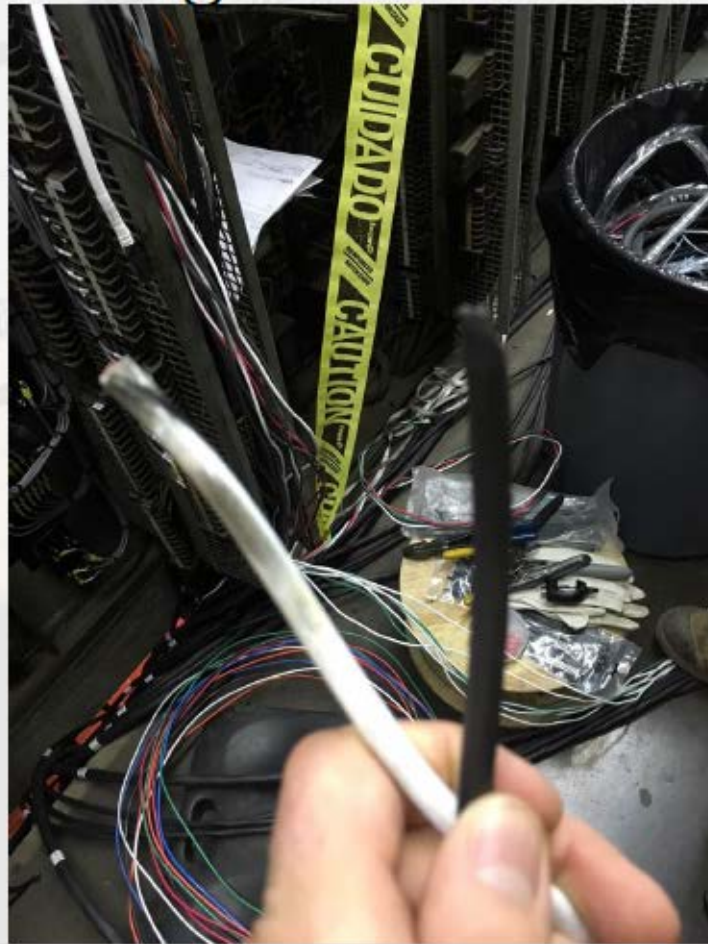
## Cable wires being cut

- Crew was wiring a relay and control panel as part of upgrade work.
- While cutting a new two-conductor cable to be used as DC supply to the panel, the cable shorted, causing an arc-flash.
- The arc extinguished, and the crew found the source and deenergized the cable.
- Worker had black marks on his hand but no signs of burns or injuries.

1. Use wiring and schematic diagrams to perform wire checks and validate schematics against wiring diagrams.
2. Use peer checks for energizing new circuits.
3. Communicate with all crews involved when changing circuit status.

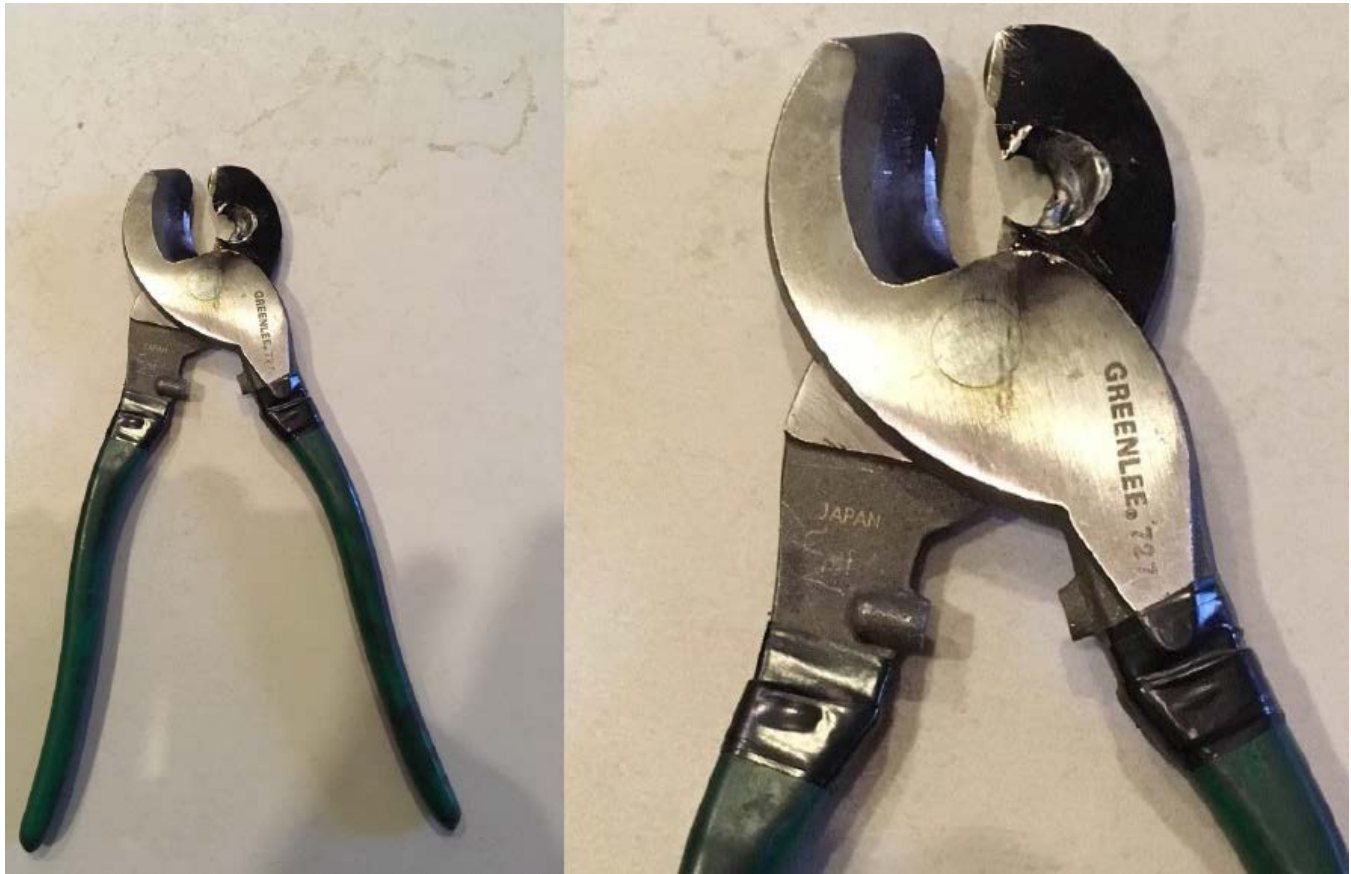
- The day prior to the incident, relay testers proceeded to energize a newly installed relay panel.
- Referring to a schematic, testers verified what components would be energized.
- The schematic they used did not show the new cable that was cut the day of the incident.
- Relay testers did not consult with the commissioning engineer about energizing the panel.
- Relay testers did not verify panel wiring against the detailed wiring diagram.
